A STUDY IN SERVICE LIFE

Decatur County, KS

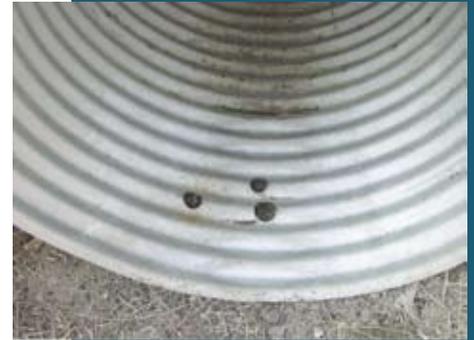
East ALT2 End

This site included two parallel 36" culverts of 12 gage pipe. The north ends (inlet) were aluminized, while the south ends were galvanized. Both ends looked good. Aluminized end still has good free aluminum coating intact; previous trepan holes had not corroded further on either end; samples were taken at the 6 o'clock position.

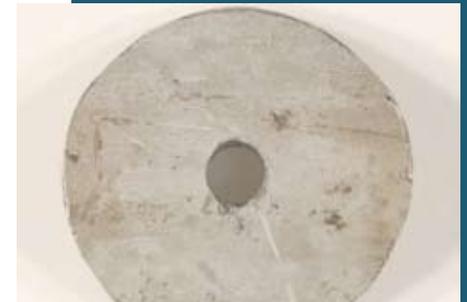
East ALT2 Water Side

East ALT2 coupons were bead blasted to remove loose oxides and images were recorded of the remaining surface (see images on previous page). Coupons show lite pitting is present on the soil side and on the water side, very close to the peak.

Micrometer Results – Ball: 0.110", 0.109", 0.109" **Point:** 0.106" (0.004" deep)

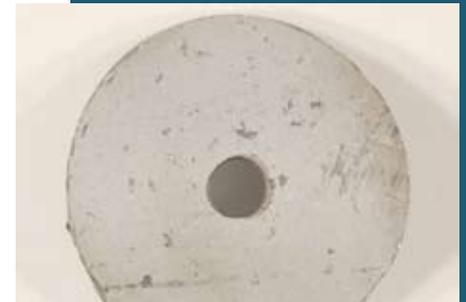
West ALT2 Water Side

West ALT2 coupons were bead blasted to remove loose oxides and images were recorded of the remaining surface (see images on right). Coupons show lite pitting is present, scattered on both the water side and soil side surfaces.

Micrometer Results – Ball: 0.107", 0.108", 0.108", 0.109" **Point:** 0.105" (0.005" deep)
