A STUDY IN SERVICE LIFE

Greene County, IL

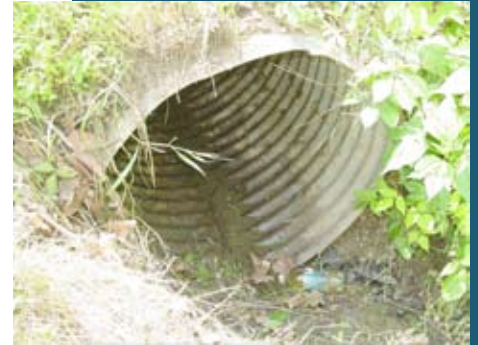
Aluminized End

36" diameter ALT2 in good condition; visually round – no apparent ovality or buckling; almost no red rust at the 6 o'clock position; approximately 5 days since last rainfall
